PUBLIC ROADS

A JOURNAL OF HIGHWAY RESEARCH

VOL. 11, NO. 4 ▽ JUNE, 1930

ILLUSTRATIONS OF FROST AND ICE PHENOMENA

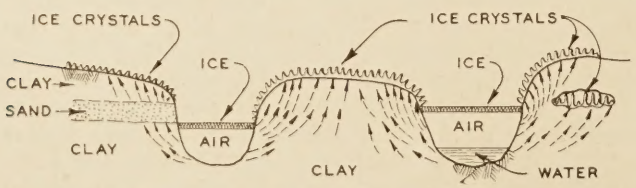
Figure 7 illustrates the occurrence of frost crystals and thin ice sheets frequently observed on clay roads which are more or less rutted. When the temperature of the ground surface reaches the freezing point, ice crystals form on the surface of moist soil, and ice forms on the surface of any pools of water which may exist

FIGURE 7.—ILLUSTRATING WATER MOVEMENTS, FROST AND ICE FORMATIONS ON A WET RUTTED CLAY SURFACE

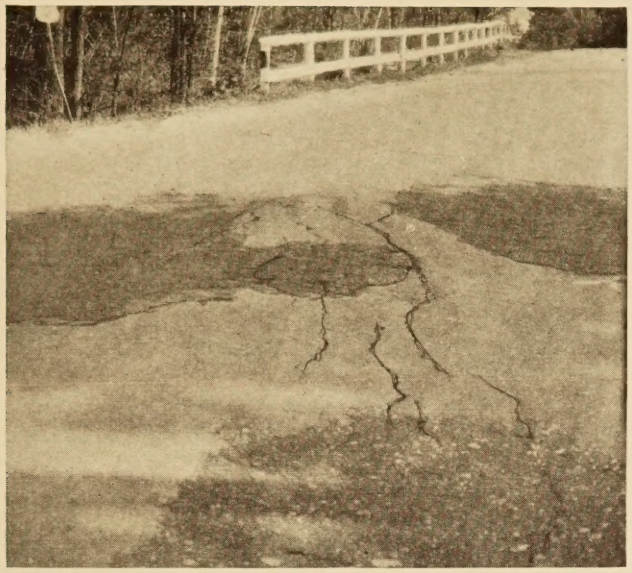
Figure 9 shows the surface appearance of a "frost boil" under a surface-treated macadam road in New Hampshire. The origin of the water in the boil was traced to a leaking water pipe beneath the subgrade. The type of soil was a fine silt which served as a water pocket. Whether this heaving was produced by solid ice or by ice crystals which had become more or less segregated from the soil by frost action is not known. It seems probable, however, that much if not all of this heaving was due largely to a mixture of ice and soil of a form somewhat like that shown in Figure 8.

FIGURE 9.—A FROST BOIL IN A SURFACE-TREATED MACADAM LAID ON BED OF SILT. THE HEAVE WAS DUE TO A LEAKING WATER PIPE BENEATH FOLLOWED BY FREEZING

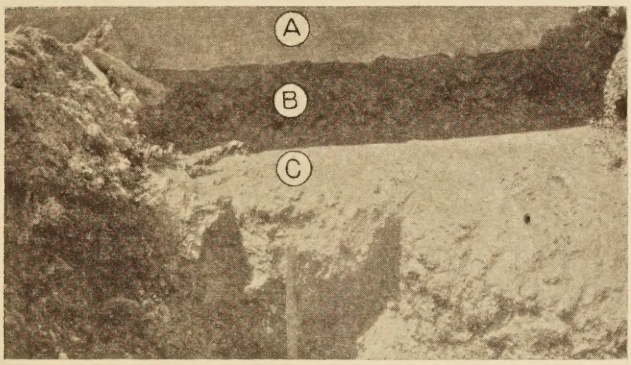
Figure 10 shows solid ice overlaid by a few inches of thawed material underlying a concrete pavement near Duluth, Minn. When first observed this frost heave must have extended 8 or 9 inches above the original grade line. The concrete pavement although heavily reinforced with longitudinal steel bars was badly shattered. An excavation made at one edge of the pavement disclosed that the pavement was laid on a bed of sand

FIGURE 10.—PHOTOGRAPH OF THE LOWER PART OF A RUPTURED CONCRETE PAVEMENT AT A; B, THE THAWED SUBGRADE; C, THE UNDERLYING PRISM OF SOLID ICE AND FROZEN CLAY UNDERNEATH

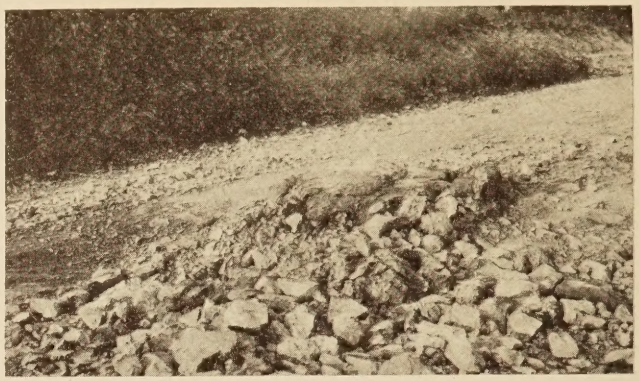
FIGURE 17.—A MUD BOIL IN A WATER-BOUND MACADAM LAID ON A FINE SANDY CLAY SOIL

The only difference between frost and mud boils is the manner in which the water accumulates. In reality discharging frost boils are nothing more than mud boils formed under frost action. Figure 17 shows a mud boil found about the middle of summer in the District of Columbia on the surface of a water-bound macadam laid on a fine sandy clay soil. This mud boil originated from a leaking water pipe and is similar in detail to the frost boils already described. It was first observed as a small mud-filled fissure on the road surface. With each passing load an eruption occurred and the volume of mud and water at the surface increased until a considerable mound was formed. Such boils may occur in any region where very fine particles of soil become reduced to the liquid state and under pressure the viscous fluid is extruded through fissures or other openings of such size as will permit its passage.

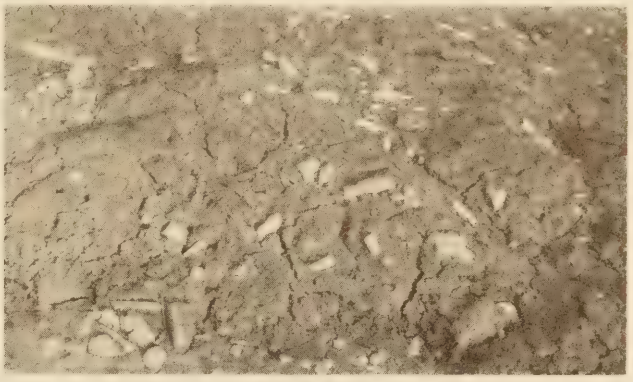
FIGURE 22.—SHRINKAGE FISSURES IN FROZEN CLAY SOIL IN THE DISTRICT OF COLUMBIA

Figure 22 illustrates fissures observed in frozen clay soil in the District of Columbia. Similar fissures ranging in width from one-eighth to one-fourth of an inch were observed also in Minnesota. In both cases the fissures contained hoar frost, but no ice crystals were observed. Hoar frost is always derived from water vapor but ice crystals such as those shown in Figure 8 are always formed from unfrozen moisture at the base of the crystals.

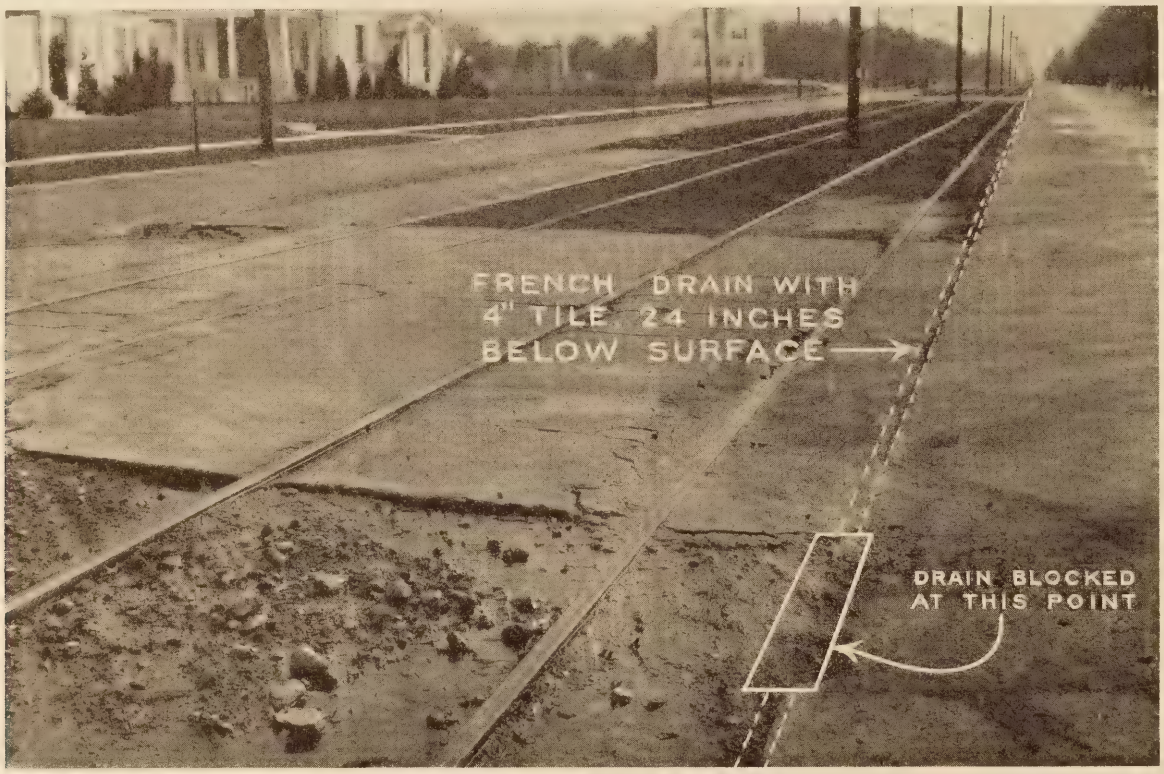
FIGURE 3.—SECTION 3, NORTH OF BRADLEY LANE, FEBRUARY, 1929. HEAVY FLOW OF WATER RISING TO THE SURFACE IMMEDIATELY UNDER WEST RAIL ON NORTH SIDE OF VIRGILIA STREET INTERSECTION. NOTE BITUMINOUS PATCH ON THE RIGHT WHICH WAS NECESSITATED BY SETTLEMENT CAUSED BY THE IMPROPER BACK FILLING OF A SERVICE CUT. THE EAST DRAIN WAS STOPPED AT THIS POINT.

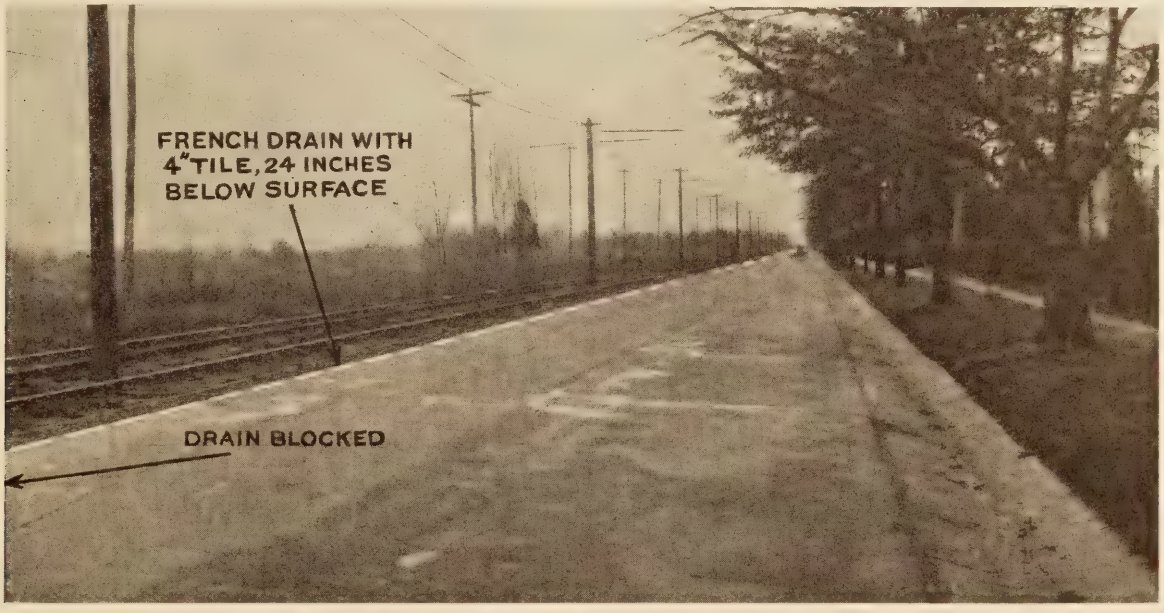
FIGURE 5.—VIEW TAKEN JUST NORTH OF CYPRESS STREET AND A FEW FEET SOUTH OF THE ENTRANCE TO COLUMBIA COUNTRY CLUB. LIGHT AREAS ARE POOLS OF WATER COLLECTING ALONG CRACKS IN THE CONCRETE. DRAIN LINE WAS BLOCKED AS INDICATED
